**DEPARTMENT OF TRANSPORTATION****DIVISION OF ENGINEERING SERVICES**

Contract #: 04-0120F4Cty: SF/ALA Rte: 80 PM: 13.2/13.9File #: 1.28**WELDING INSPECTION REPORT****Resident Engineer:** Pursell, Gary**Address:** 333 Burma Road**City:** Oakland, CA 94607**Report No:** WIR-014497**Date Inspected:** 27-May-2010**Project Name:** SAS Superstructure**OSM Arrival Time:** 630**Prime Contractor:** American Bridge/Fluor Enterprises, a JV**OSM Departure Time:** 1500**Contractor:** American Bridge/Fluor Enterprises, a JV**Location:** Job Site

**Summary of Items Observed:**

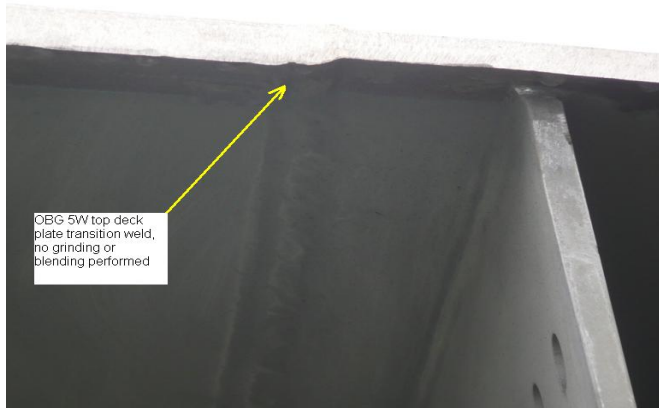
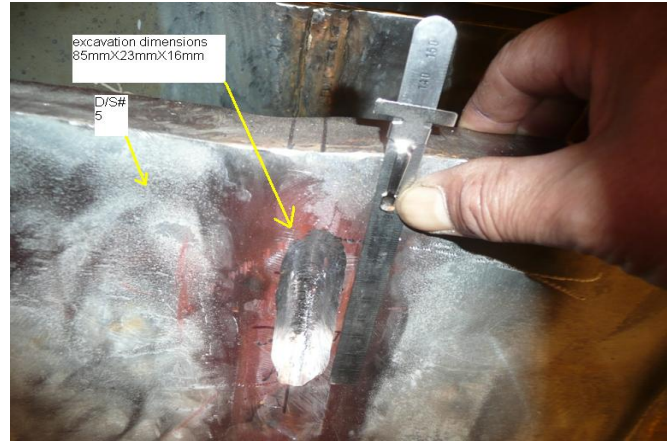
The QA Inspector randomly observed the American Bridge/Fluor (ABF) welder identified as James Zhen excavating a UT rejection. The QA Inspector randomly observed and noted the area was previously indicated with a distinguishing marking directly on the weld which had been ground flush with the base material. The QA Inspector randomly observed the ABF welder excavate the UT rejection utilizing a burr bit grinder. Once the excavation was ground and blended to a weld able profile, the SE QC Inspector Jesse Cayabyab performed magnetic particle testing (MT) of the excavated area. The QA Inspector noted no relevant indications were located at the time of the testing. The QA Inspector performed random dimensional measurements of the excavated area and noted it was 90mm x 19mm x 12mm deep. The QA Inspector randomly observed the ABF welder preheat the isolated area of the excavation utilizing a rosebud torch. After the minimum required preheat was achieved, the QA Inspector noted the ABF welder began the shielded metal arc welding (SMAW) repair. The QA Inspector noted the ABF welder was performing the SMAW repair for the remainder of the QA Inspectors shift.

The QA Inspector noted the ABF welder identified as Chun Fai Tsui was performing grinding in an attempt to excavate and remove the UT rejections previously located and indicated by the SE QC Inspectors. The QA Inspector noted the above identified longitudinal stiffener weld appeared to have two UT rejections. The QA Inspector noted the same excavation and MT inspections were performed as noted above. The QA Inspector performed random dimensional measurements of the excavated area and noted it was 85mm x 23mm x 16mm deep and 90mm x 24mm x 23mm deep. The QA Inspector noted both of the excavated areas appeared have been ground and blended to a weld able profile. The QA Inspector randomly observed the ABF welder preheat the isolated area of the excavation utilizing a rosebud torch. After the minimum required preheat was achieved, the QA Inspector noted the ABF welder began the shielded metal arc welding (SMAW) repair. The QA Inspector noted the ABF welder was performing the SMAW repair for the remainder of the QA Inspectors shift.
